AFWAL-TR-85-4150
Volume 2

DEVELOPMENT OF FRACTURE MECHANICS MAPS
FOR COMPOSITE MATERIALS

DFVLR - Institute for Structural Mechanics
Braunschweig, West Germany

Final Report for Period January 1982 - January 1985

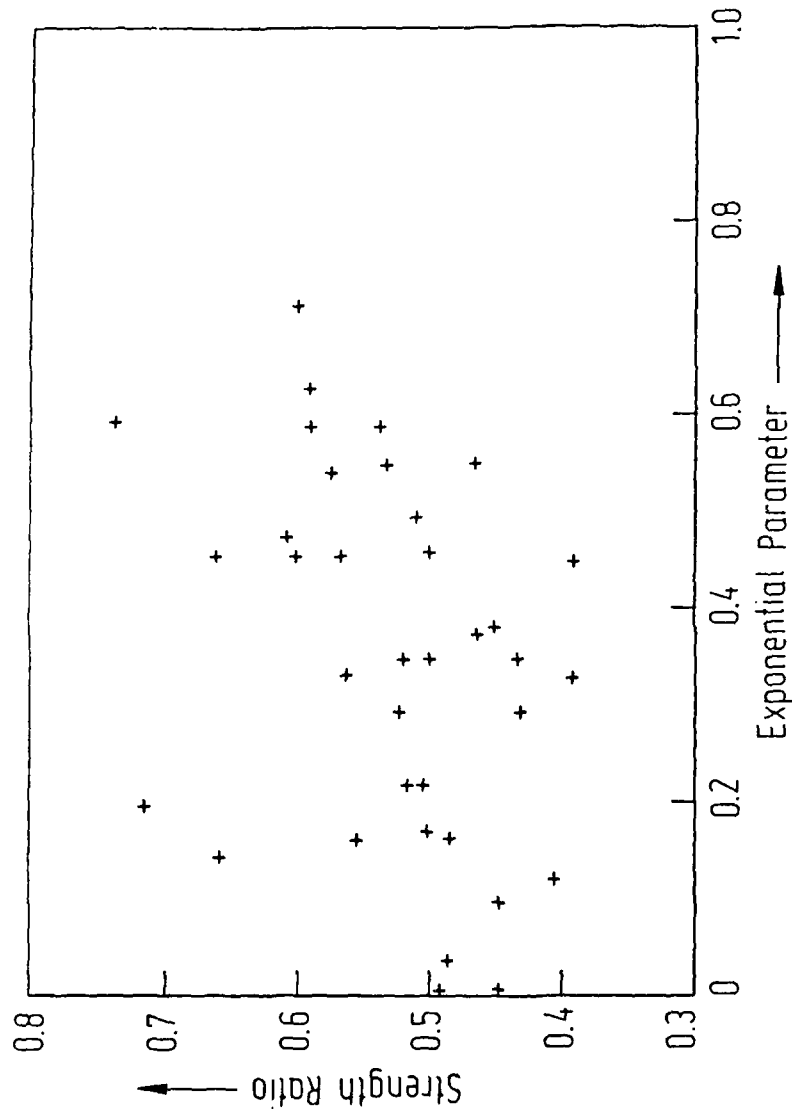
Fig. 15.5 Correlation between notched strength ratio and exponential parameter, m , (PWG-fracture model) for graphite/epoxy laminates containing circular holes ($2R/W = 0.25$).

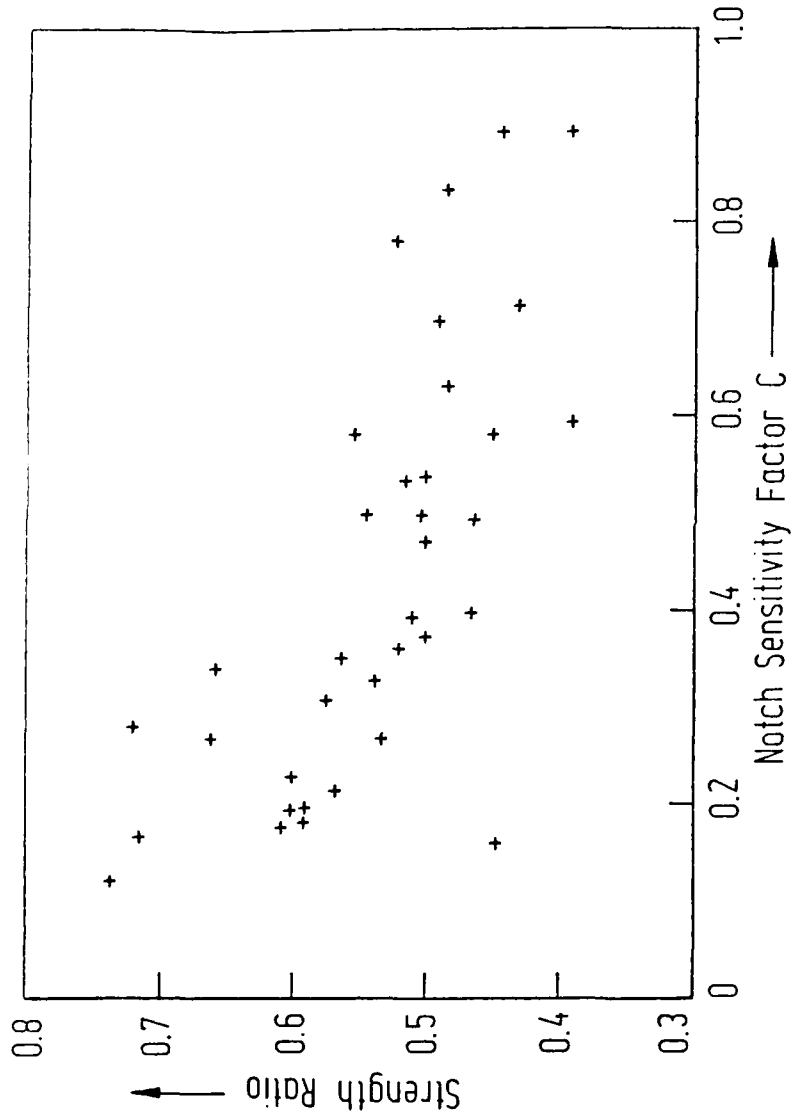
Fig. 15.6 Correlation between notched strength ratio and notched sensitivity factor, C , (PWG-fracture model) for graphite/epoxy laminates containing circular holes ($2R/W = 0.25$).

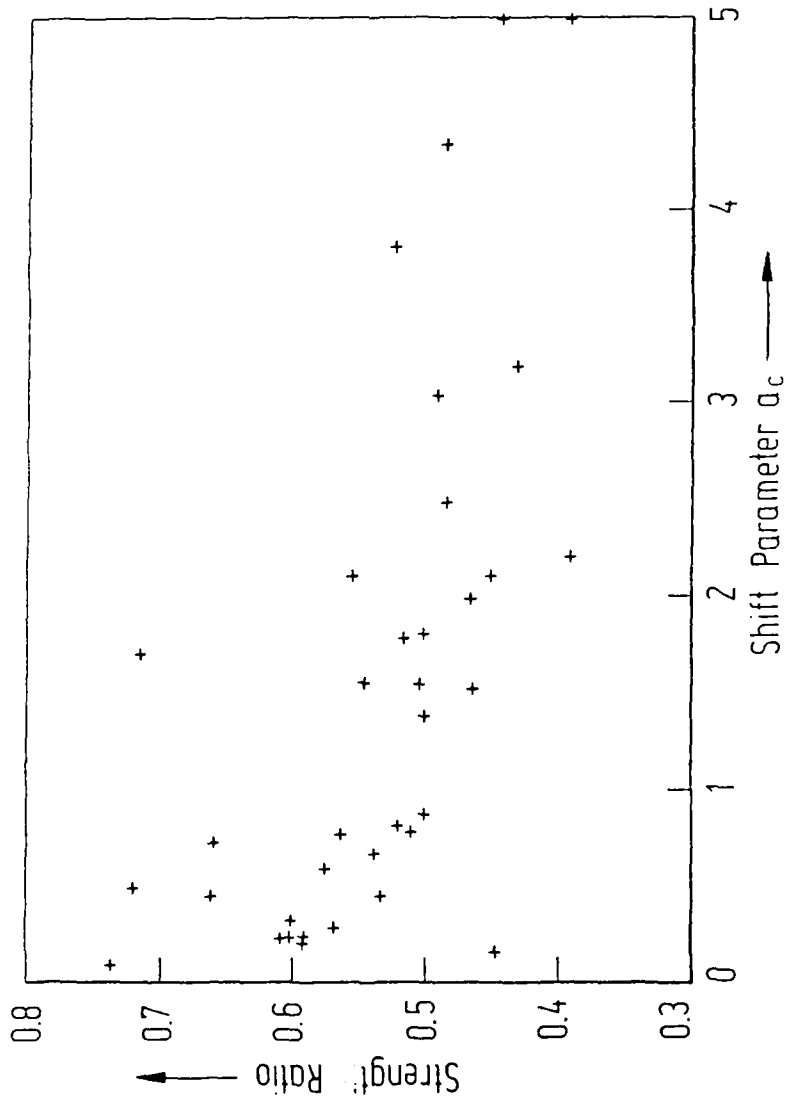
Fig. 15.7 Correlation between notched strength ratio and shift parameter, a_c , (PWG-fracture model) for graphite/epoxy laminates containing circular holes ($2R/W = 0.25$).

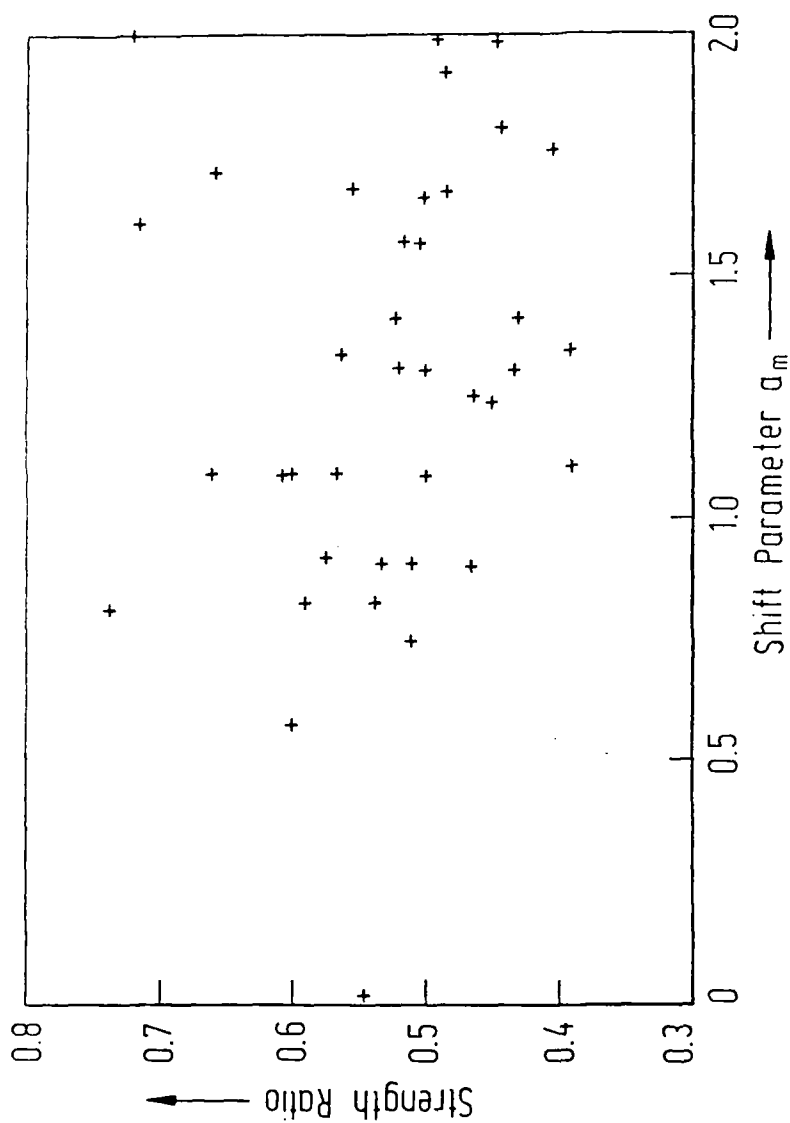
Fig. 15.8 Correlation between notched strength ratio and shift factor, a_m , (PWC-fracture model) for graphite/epoxy laminates containing circular holes ($2R/W = 0.25$).

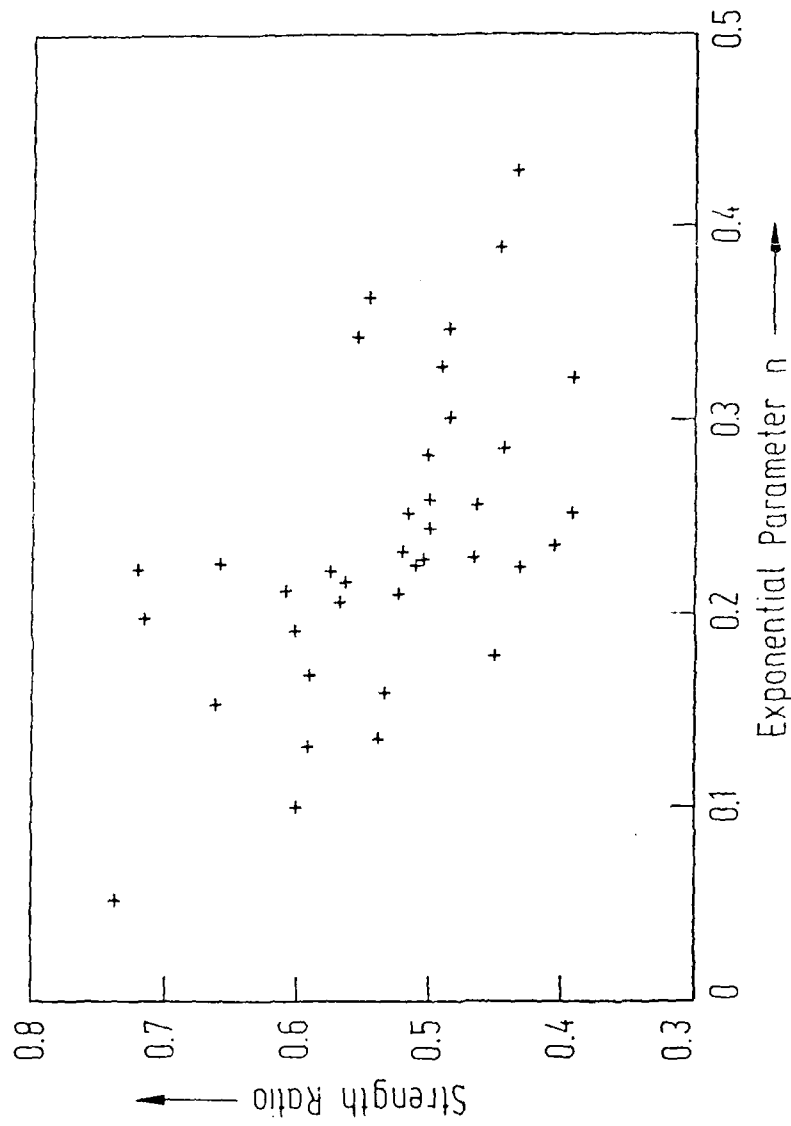
Fig. 15.9 Correlation between notched strength ratio and exponential parameter, n , (ML-fracture model) for graphite/epoxy laminates containing circular holes ($2R/W = 0.25$).

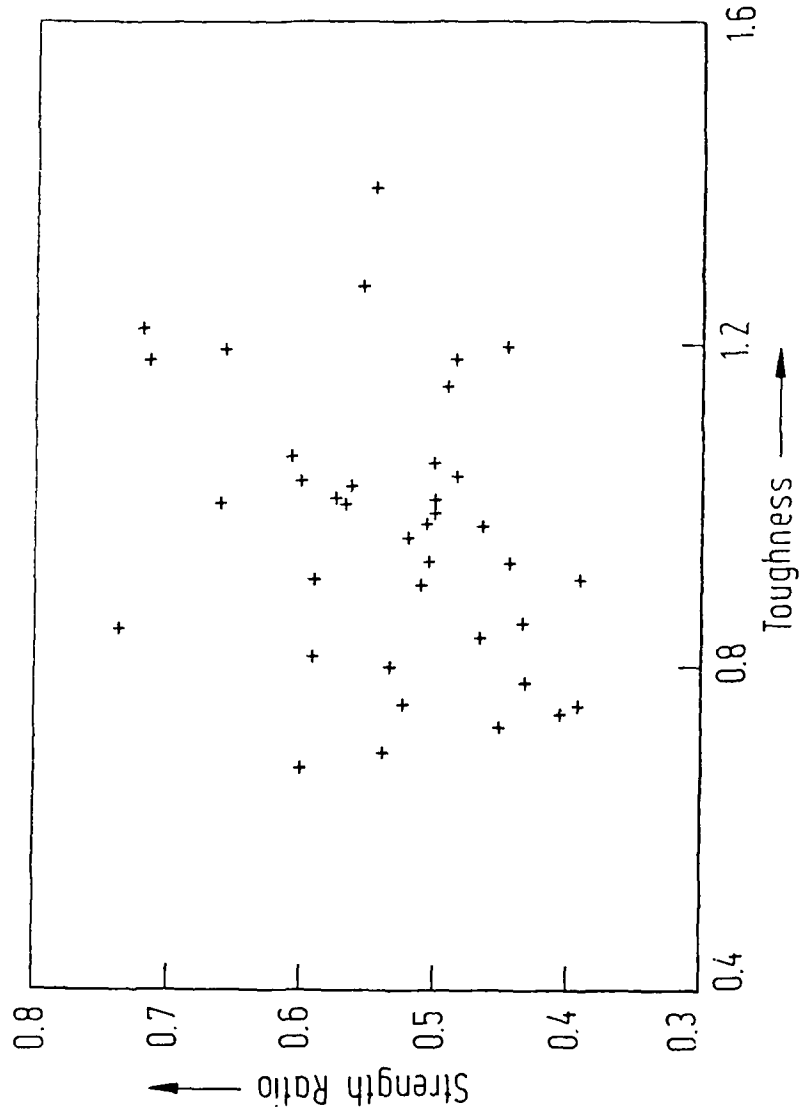
Fig. 15.10 Correlation between notched strength ratio and composite fracture toughness, H_c/a_0 , (ML-fracture model) for graphite/epoxy laminates containing circular holes ($2R/W = 0.25$).

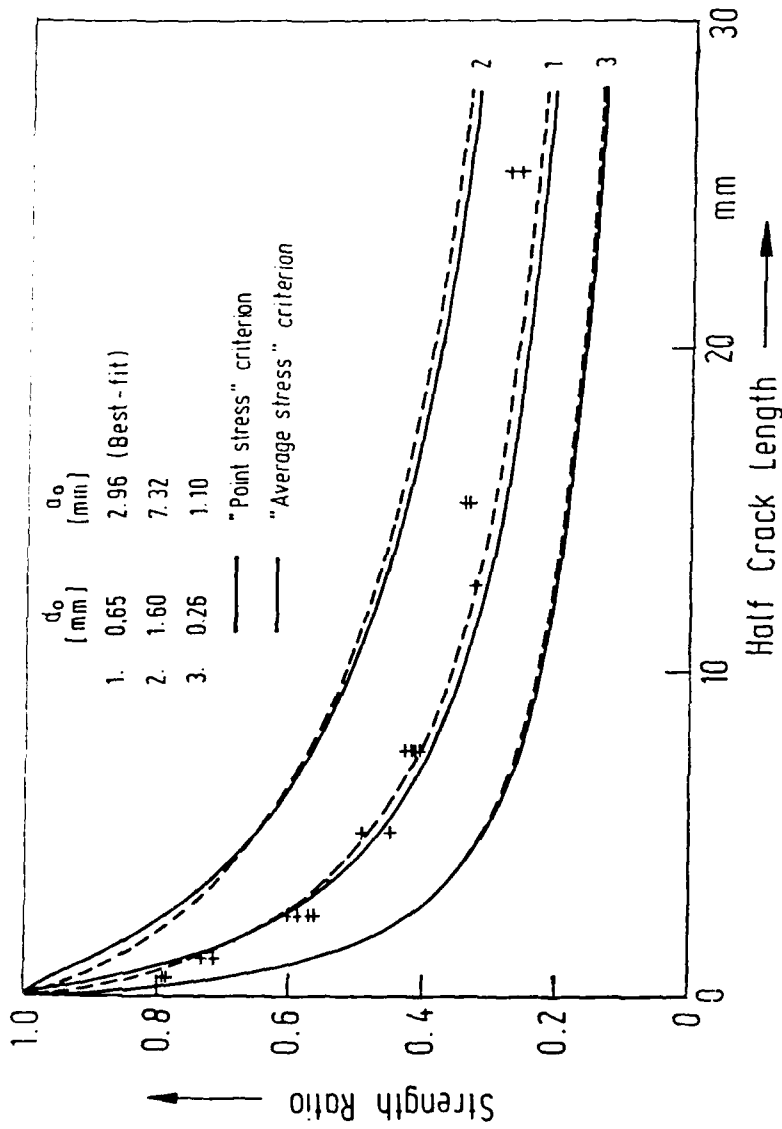
Fig. 15.11 Effect of the characteristic dimensions (WN-fracture model) on notched strength of boron/aluminum laminates containing straight cracks.

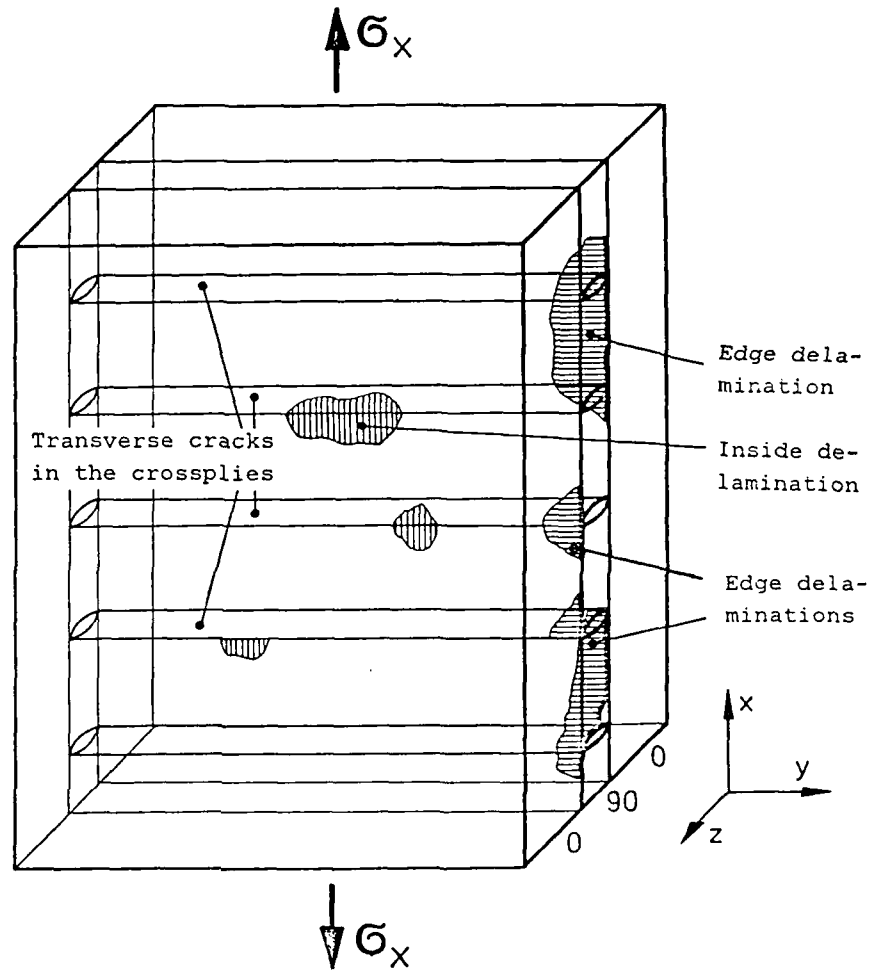
Fig. 16.1 Matrix cracks in the crossplies and onset of delaminations both inside the specimen and on its free edges.

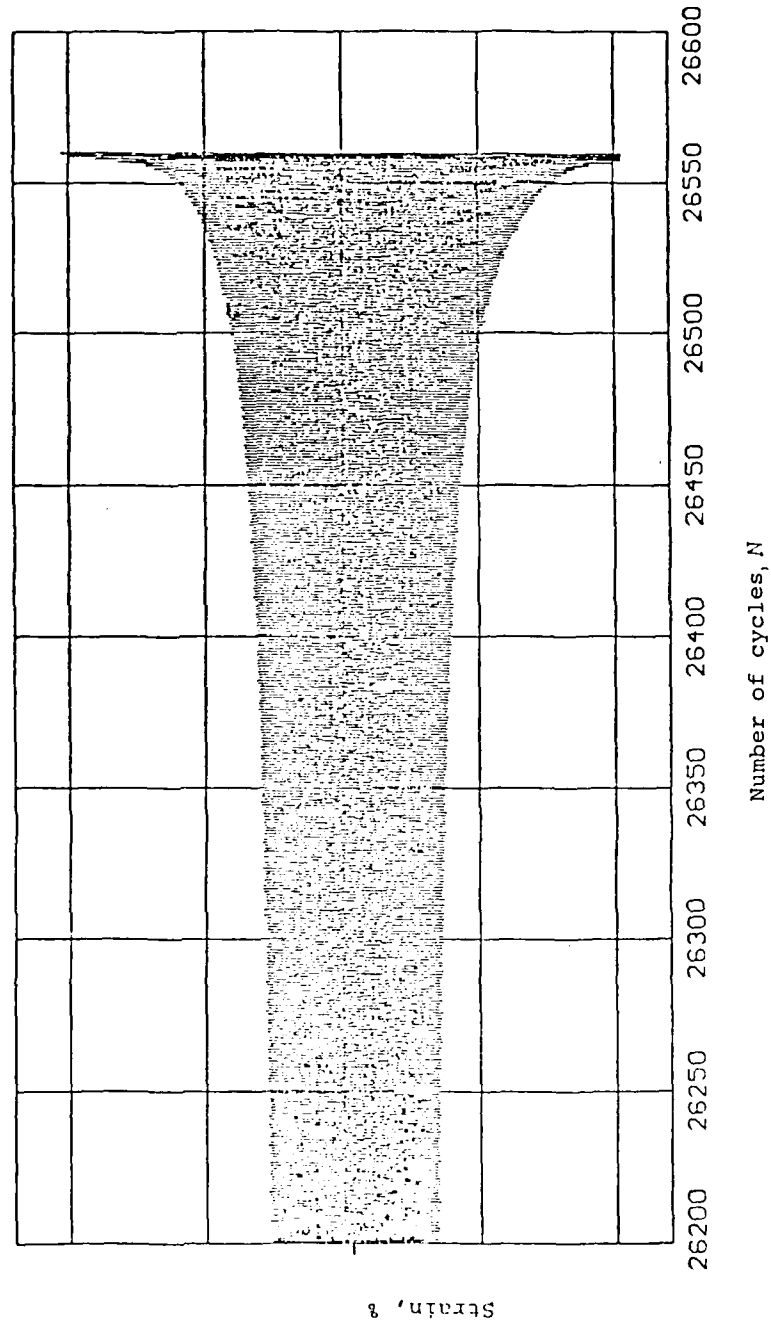
Fig. 16.2 Gradual increase of strain during load-controlled tension-compression test. Laminate Stacking order $[\pm 45^\circ]_{2s}$.

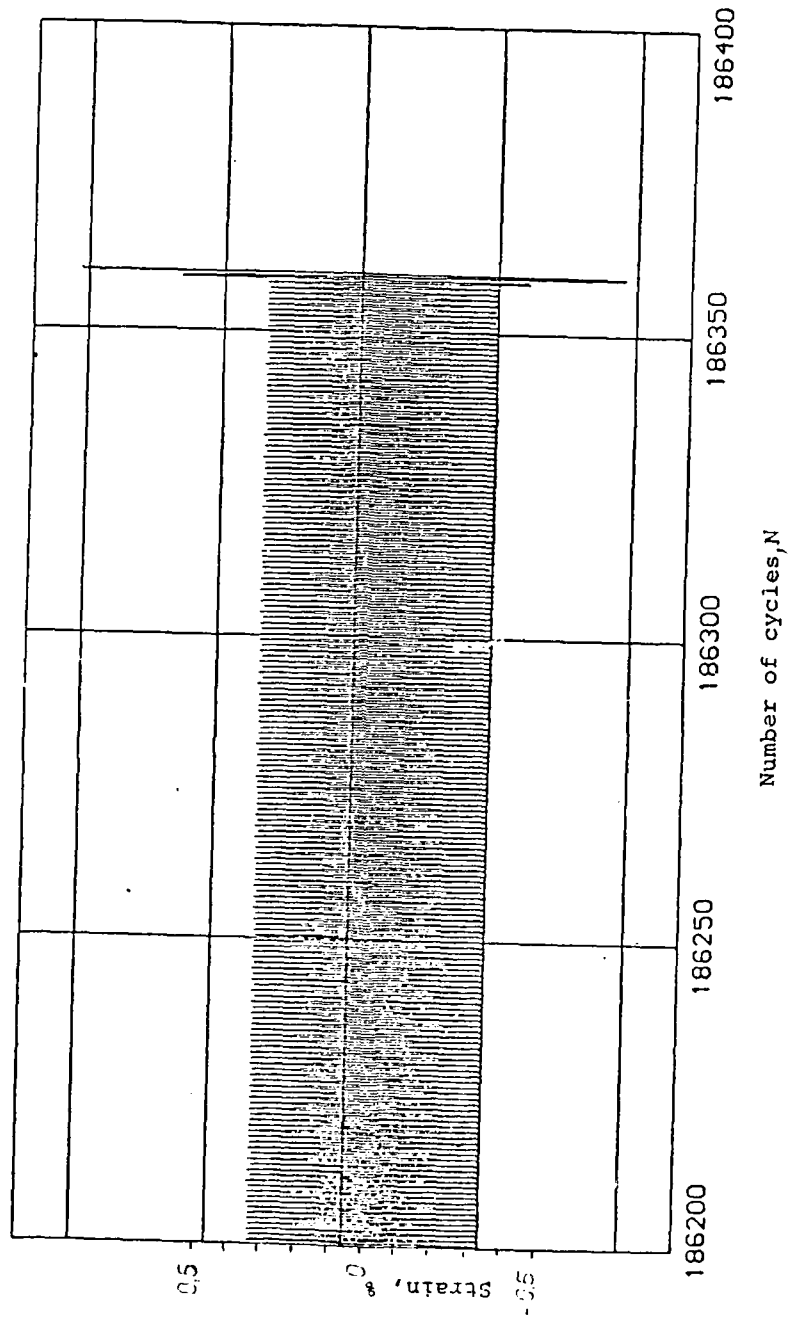
Fig. 16.3 Sudden increase of strain during the last two cycles before failure in load-controlled tension-compression test. Laminate stacking order $[0_2, +45, 0_2, -45, 0, 90]_s$.

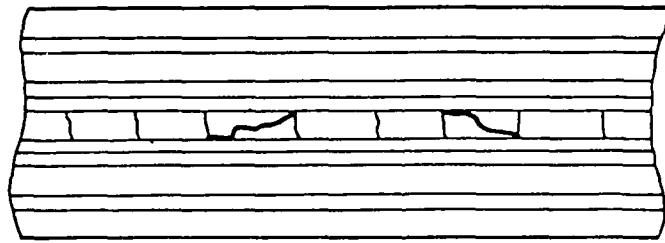
Edge Delamination
Onset Spanning the Entire Length

$0_2/-45/0_2/-45/0/90_2/0/-45/0_2/-45/0_2$

Fig. 16.8: Crack opening micrographs under tension-compression loading, $\sigma = \pm 500 \text{ N/mm}^2$.

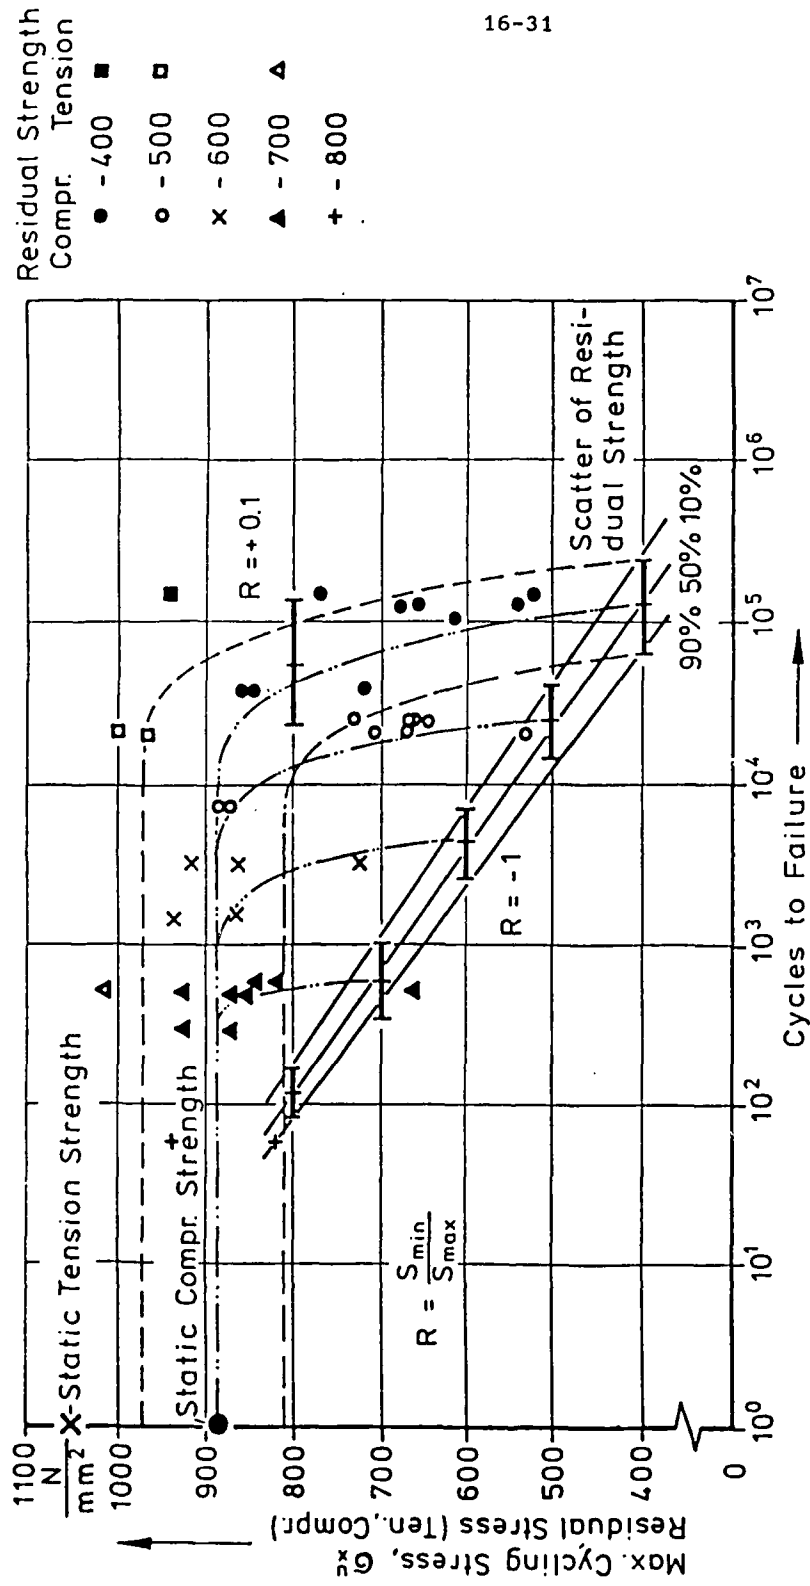
Fig. 16.19 S-N-curve and residual strength vs. cycles to failure

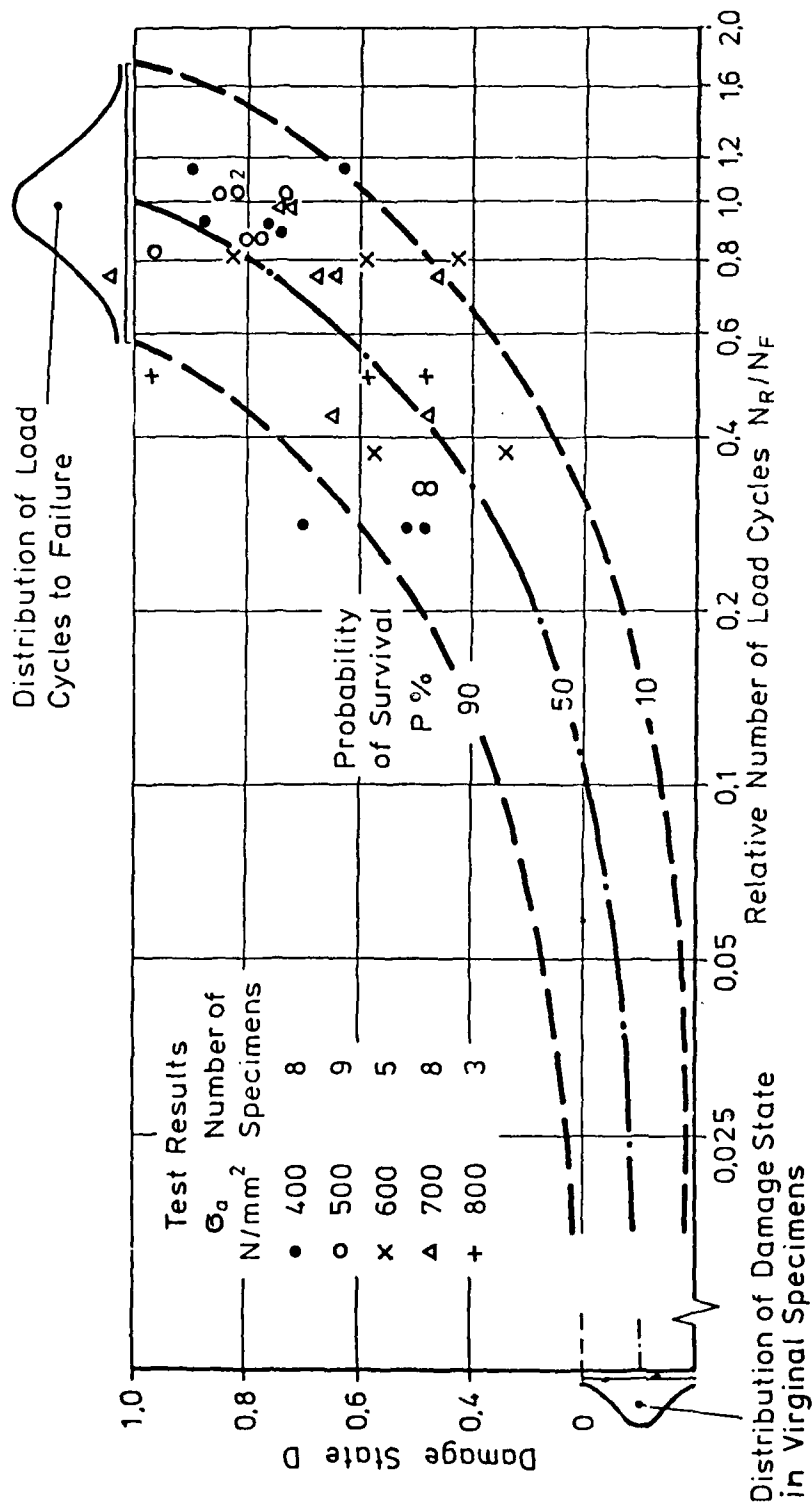
Fig. 16.20 Damage state determined from compressive residual strength.

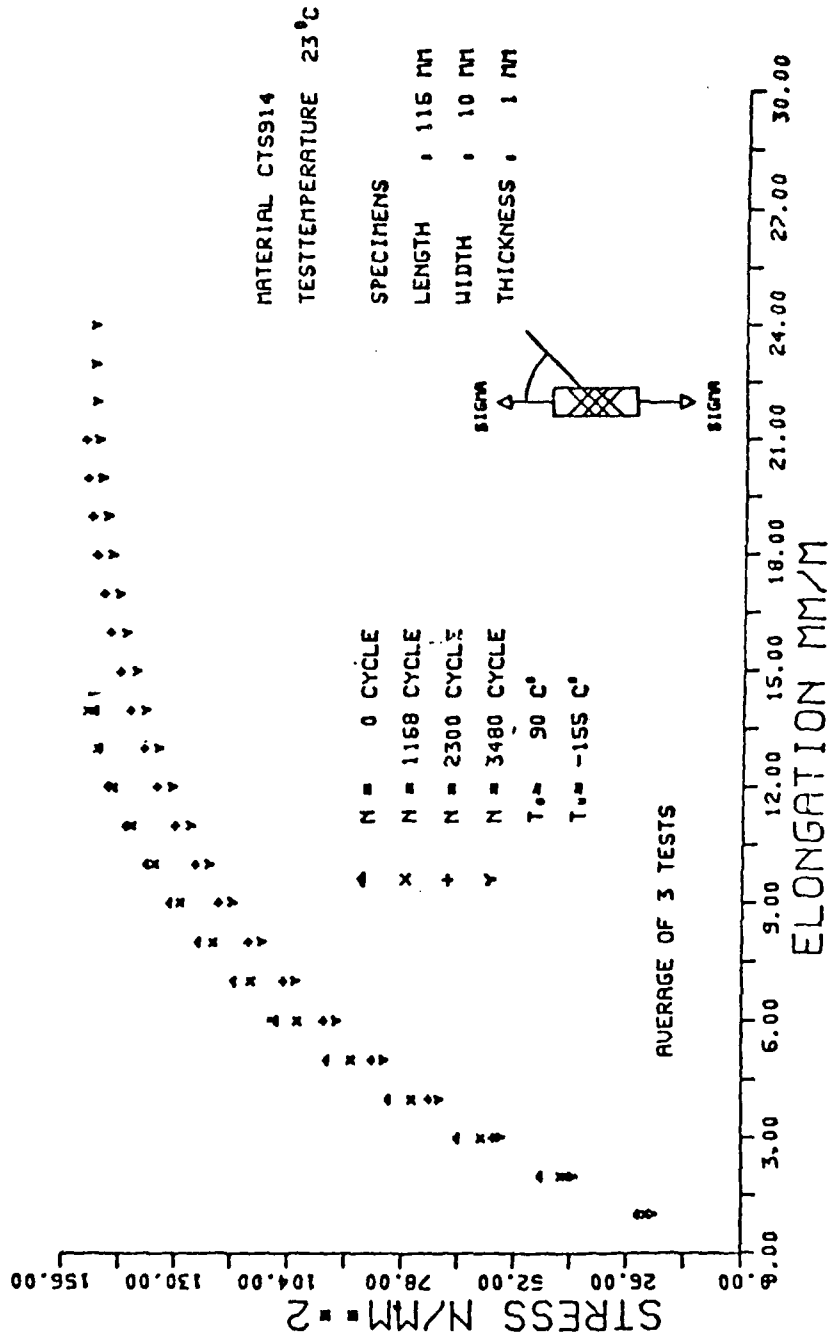
Fig. 16.27 Stress-strain curves from tension tests of $[+45^\circ]_{2s}$ specimens after thermal cycling.
